FENTON ENVIRONMENTAL SERVICES

Asbestos Refurbishment/Demolition Survey

Flat G
53 Warminster Road
London SE25 4DQ

Survey ID: SF-A-22-642
Surveyor: Steve Fenton
Survey Date: 21st November 2022
Report Date: 21st November 2022

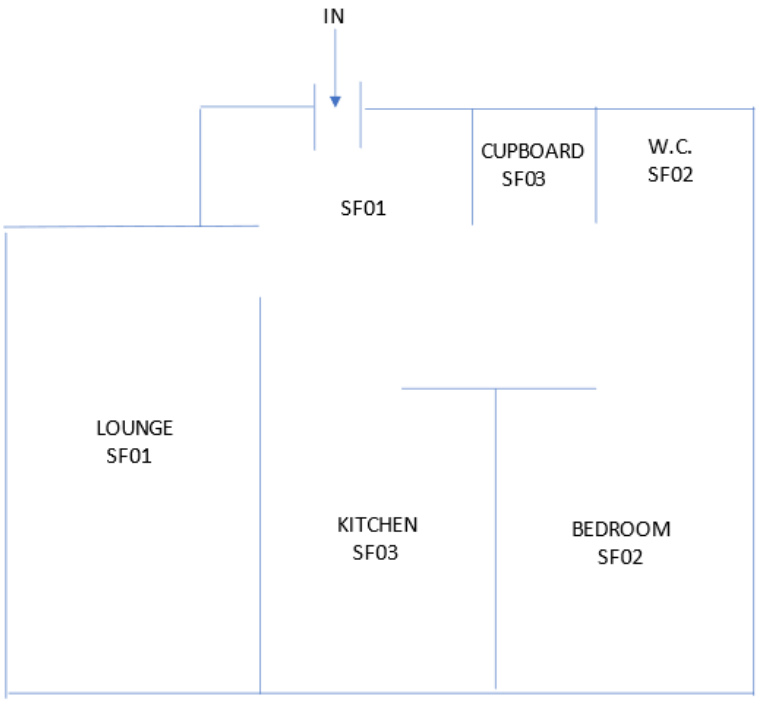
Close up of sample area

Sample Reference: SF03/Flat G 53 Warminster Rd SE25 4DQ			
REFURBISHMENT/DEMOLITION SURVEY			
Surveyor:	Steve Fenton	Date:	14th October 2022
Floor:	Basement	Room:	Kitchen & Hallway cupboard
Product type:	No asbestos detected	Condition:	N/A
Surface treatment:	N/A	Quantity:	N/A
Accessibility:	N/A	Asbestos type:	N/A
Identification:	Negative	Material risk sore:	N/A
Comments:	Modern lino to timber floor Plaster to walls and ceilings No asbestos detected		
Action:	None
