Asbestos Refurbishment/Demolition Survey

Flat C
53 Warminster Road
London SE25 4DQ

Survey ID: SF-A-22-616
Surveyor: Steve Fenton
Survey Date: 14th October 2022
Report Date: 17th October

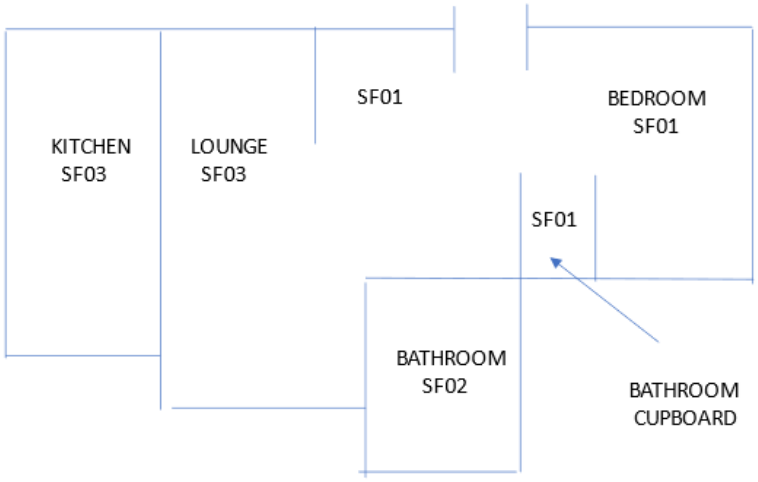
FLAT 'C'

KITCHEN
SF03
LOUNGE
SF03
SF01
BEDROOM
SF01
SF01
BATHROOM
SF02
BATHROOM
CUPBOARD
