Asbestos Refurbishment/Demolition Survey

Flat D
53 Warminster Road
London SE25 4DQ

Survey ID: SF-A-22-617
Surveyor: Steve Fenton
Survey Date: 14th October 2022
Report Date: 17th October

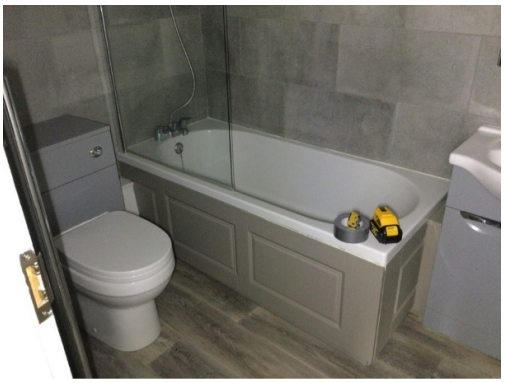
Sample Reference: SF01/Flat D 53 Warminster Rd SE25 4DQ			
REFURBISHMENT/DEMOLITION SURVEY			
Surveyor:	Steve Fenton	Date:	14th October 2022
Floor:	First	Room:	Hallway and bathroom
Product type:	No asbestos detected	Condition:	N/A
Surface treatment:	N/A	Quantity:	N/A
Accessibility:	N/A	Asbestos type:	N/A
Identification:	Negative	Material risk sore:	N/A
Comments:	Carpet to timber floor Plaster to ceilings and wall Modern lino in bathroom No asbestos detected		
Action:	None

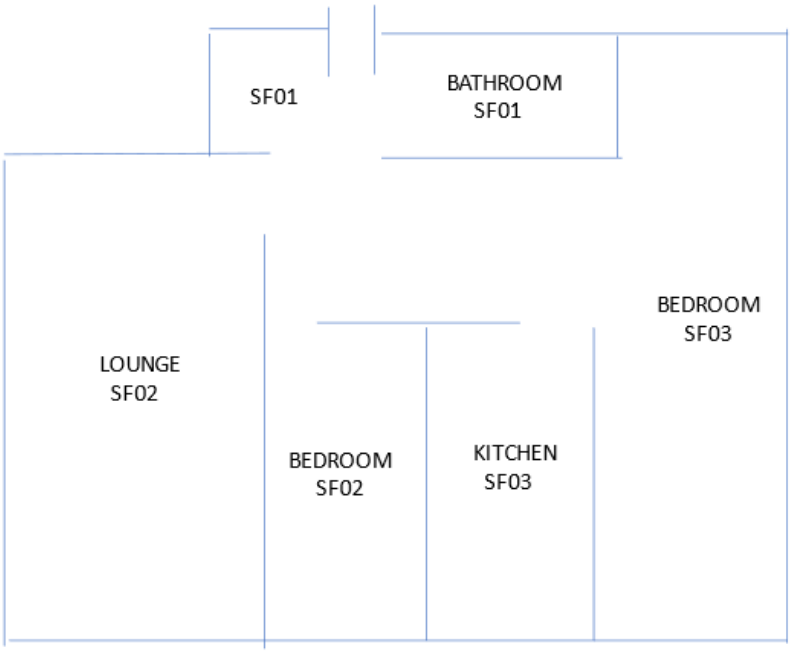
FLAT 'D'

SF01
BATHROOM
SF01
BEDROOM
SF03
LOUNGE
SF02
BEDROOM
SF02
KITCHEN
SF03
