Asbestos Refurbishment/Demolition Survey

Flat E
53 Warminster Road
London SE25 4DQ

Collins Contractors Ltd

Survey ID: SF-A-22-641
Surveyor: Steve Fenton
Survey Date: 21st November 2022
Report Date: 21st November 2022

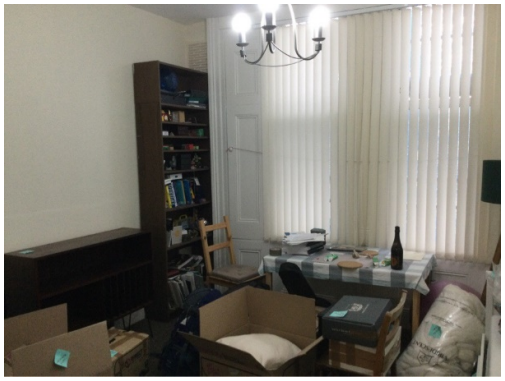
Sample Reference: SF01/Flat E 53 Warminster Rd SE25 4DQ			
REFURBISHMENT/DEMOLITION SURVEY			
Surveyor:	Steve Fenton	Date:	14th October 2022
Floor:	Ground	Room:	Hallway & Bedroom
Product type:	No asbestos detected	Condition:	N/A
Surface treatment:	N/A	Quantity:	N/A
Accessibility:	N/A	Asbestos type:	N/A
Identification:	Negative	Material risk sore:	N/A
Comments:	Carpet to timber floor Plaster to walls and ceilings No asbestos detected		
Action:	None

Close up of sample area

General area of sample

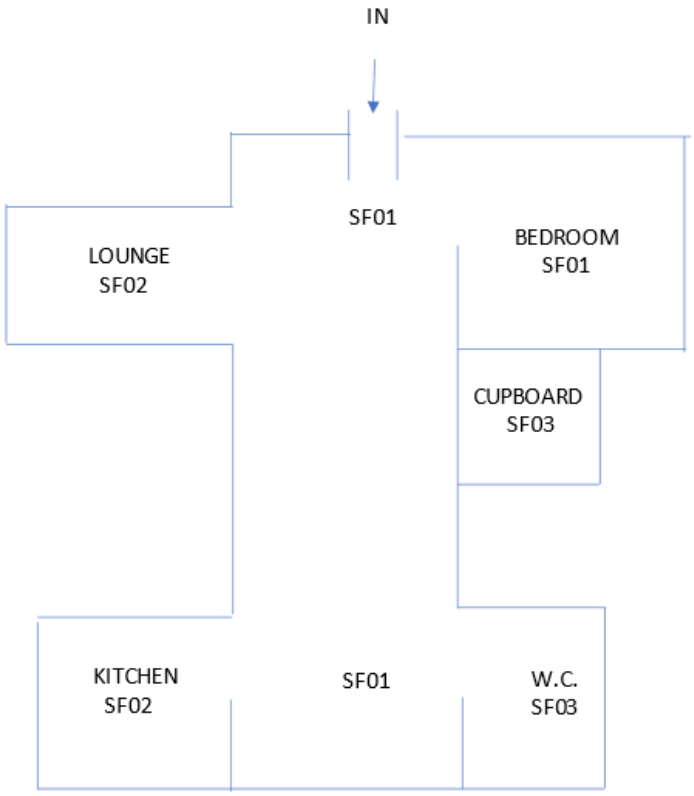
Sample Reference: SF03/Flat E 53 Warminster Rd SE25 4DQ			
REFURBISHMENT/DEMOLITION SURVEY			
Surveyor:	Steve Fenton	Date:	14th October 2022
Floor:	Ground	Room:	Kitchen & Bathroom
Product type:	No asbestos detected	Condition:	N/A
Surface treatment:	N/A	Quantity:	N/A
Accessibility:	N/A	Asbestos type:	N/A
Identification:	Negative	Material risk sore:	N/A
Comments:	Modern lino to timber floor Plaster to walls and ceiling No asbestos detected		
Action:	None

Close up of sample area

General area of sample
