53 WARMINSTER RD - PROGRESS

Thursday, 10 November 2022

Prepared For Brymore No 1 Ltd

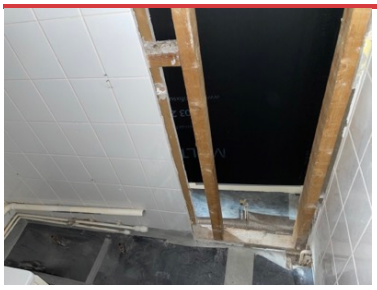
OBSERVATION 8

Ground floor Flat F

Lounge looking to kitchen
